Updated Assessment of Active Faults in the Kaikōura District

**GNS Science Consultancy Report 2018/141
September 2019**

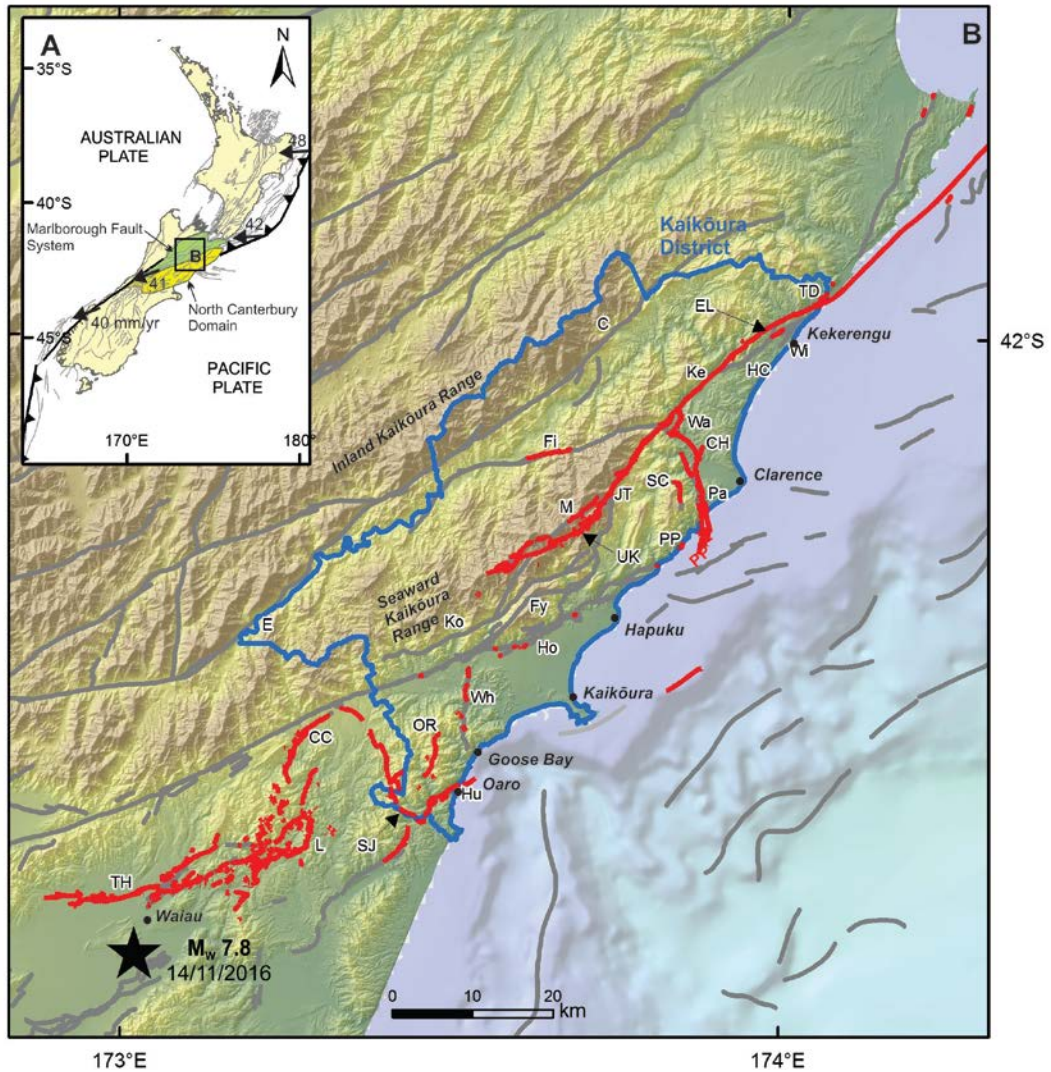
Figure 1.1 A) Tectonic setting with simplified active faults and tectonic domains. The Pacific Plate motion vectors are from Wallace et al. (2007). B) Active faults (red and grey lines) in and near the Kaikōura District. Red lines are faults that ruptured the ground surface / sea bed in the 2016 Kaikōura Earthquake, which are from this study, and the grey lines are from the New Zealand Active Faults Database <https://data.gns.cri.nz/af/> (Langridge et al. 2016). C is the Clarence Fault, CC is the Conway-Charwell Fault, CH is the Corner Hill Fault, E is the Elliott Fault, EL is the East Lane Fault, Fi is the Fidget Fault, Fy is the Fyffe Fault, HC is the Heaver's Creek Fault, Ho is the Hope Fault, Hu is the Hundalee Fault, JT is the Jordan Thrust, Ke is the Kekerengu Fault, Ko is the Kowhai Fault, L is the Leader fault, M is the Manakau Fault, OR is the Oaro River Fault, Pa is the Papatea Fault, PP is the Paparua Point Fault, SC is the Stewart Creek Fault, SJ is the Stone Jug Fault, TD is the Tinline Downs Fault, TH is The Humps Fault, UK is the Upper Kowhai Fault, Wa is the Waiautoa Fault, Wh is the Whites Fault, and Wi is the Winterholme Fault.

The 2016 Kaikōura Earthquake started in the North Canterbury Domain, near Waiiau, and ruptured north-eastwards, crossing the Hope Fault into the Marlborough Fault System (Figure 1.1B). In general, the surface fault ruptures were shorter, less continuous, and the displacements smaller in the North Canterbury Domain, than in the Marlborough Fault System.

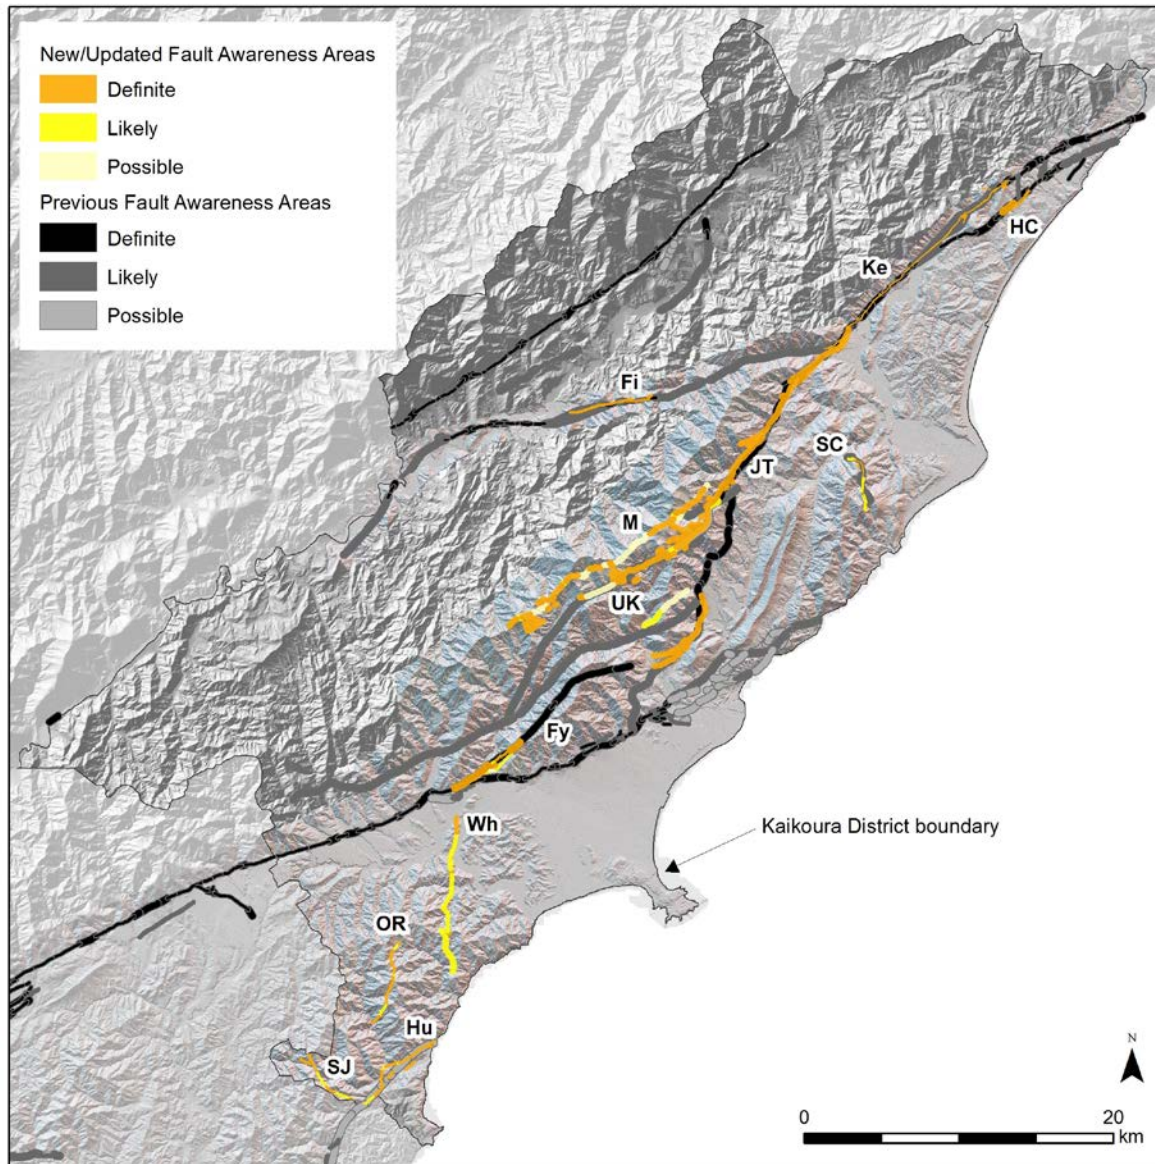
Figure 2.1 New, updated, and previously-defined (Barrell, 2015) Fault Awareness Areas in the Kaikōura District. Fi is the Fidget Fault, Fy is the Fyffe Fault, HC is the Heaver’s Creek Fault, Hu is the Hundalee Fault, JT is the Jordan Thrust, Ke is the Kekerengu Fault, M is the Manakau Fault, OR is the Oaro River Fault, SC is the Stewart Creek Fault, SJ is the Stone Jug Fault, UK is the Upper Kowhai Fault and Wh is the Whites Fault.

The new and updated Fault Awareness Areas are shown on Figure 2.1 and are summarised for each fault below. The new and updated Fault Awareness Areas replace the previously-defined Fault Awareness Areas, which are also shown for comparison purposes. Maps without the previously-defined Fault Awareness Areas are contained in Appendix 1.0.

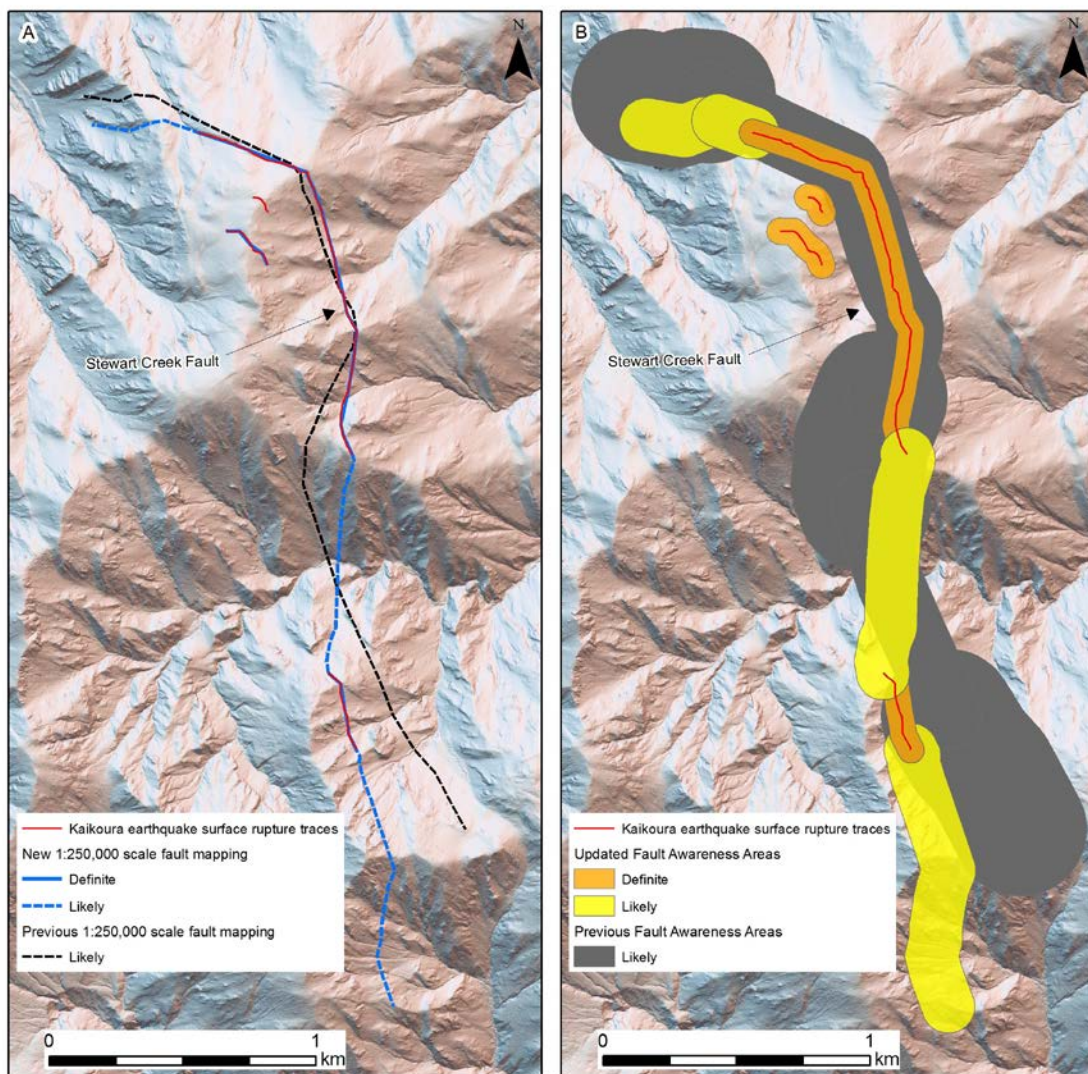
Figure 2.9 A) New and previous mapping of the Stewart Creek Fault. B) Updated and previous Fault Awareness Areas for the Stewart Creek Fault. A version of this figure without the previous Fault Awareness Areas is contained in Appendix 1.0.

The Stewart Creek Fault was mapped by Barrell (2015) as a “Likely” active fault, and ~2 km of the fault ruptured in the Kaikōura Earthquake (Figure 1.1; Langridge et al. 2018). The 2016 ruptures were predominantly normal faults and formed a series of discontinuous fault traces that we infer to form one main fault trace, with two subsidiary faults (Figure 2.9A).

Fault Awareness Areas were updated from the 1:250,000 scale fault mapping and the subsidiary faults using a buffer width of 50 m on either side of the 2016 rupture traces and 100 m either side of the remaining traces (Figure 2.9B). Most of the Fault Awareness Areas fall within or overlap the previously-defined Fault Awareness Areas.

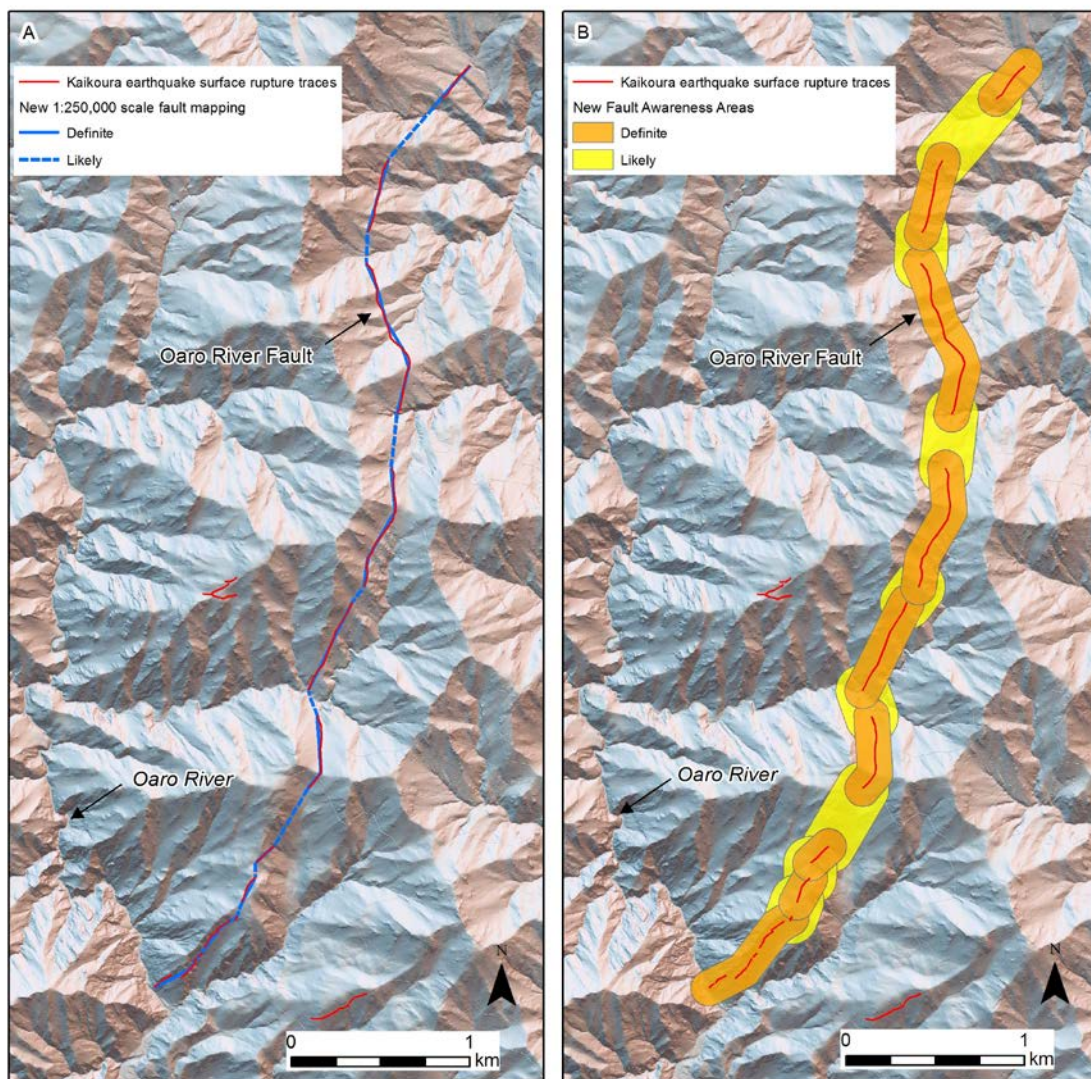
Figure 2.11 A) New mapping of the Oaro River Fault. B) New Fault Awareness Areas for the Oaro River Fault.

The Oaro River Fault had not been mapped prior to the Kaikōura Earthquake and was only identified during the late stages of the earthquake response, and so has not been named previously (e.g., it is shown on the surface rupture map of Litchfield et al. (2018) but is not named or discussed). The 2016 ruptures were initially identified in the LiDAR data and were field verified as small (<0.5 m vertical) ruptures from helicopter, but as far as we are aware, no one has visited it on the ground. The fault traces are discontinuous, but lie along-strike from each other so, like the Whites Fault, we infer it to be a single fault and have mapped “Likely” traces linking the 2016 ruptures (Figure 2.11A).

New Fault Awareness Areas were generated from the fault traces mapped at 1:250,000 scale. The buffer width is 100-m-wide buffer either side of the “Definite” (2016) traces and 150-m-wide buffer either side of the remaining, “Likely” traces (Figure 2.11B).

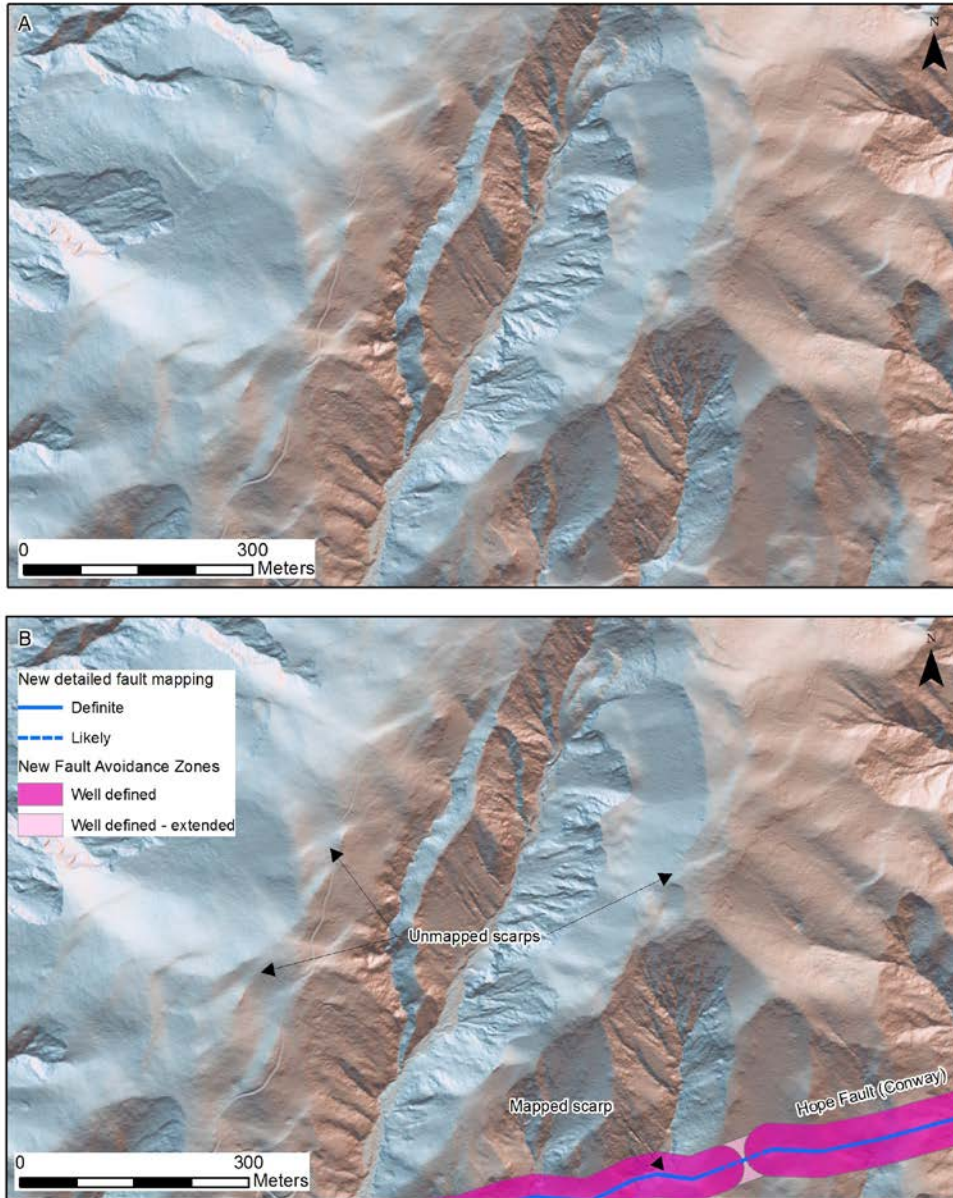
Figure 3.10 Scarps visible on the LiDAR data on the hillslopes above the Hope Fault, some of which are not included in Fault Avoidance Zones because their origin as a fault rather than a landslide feature is unclear.

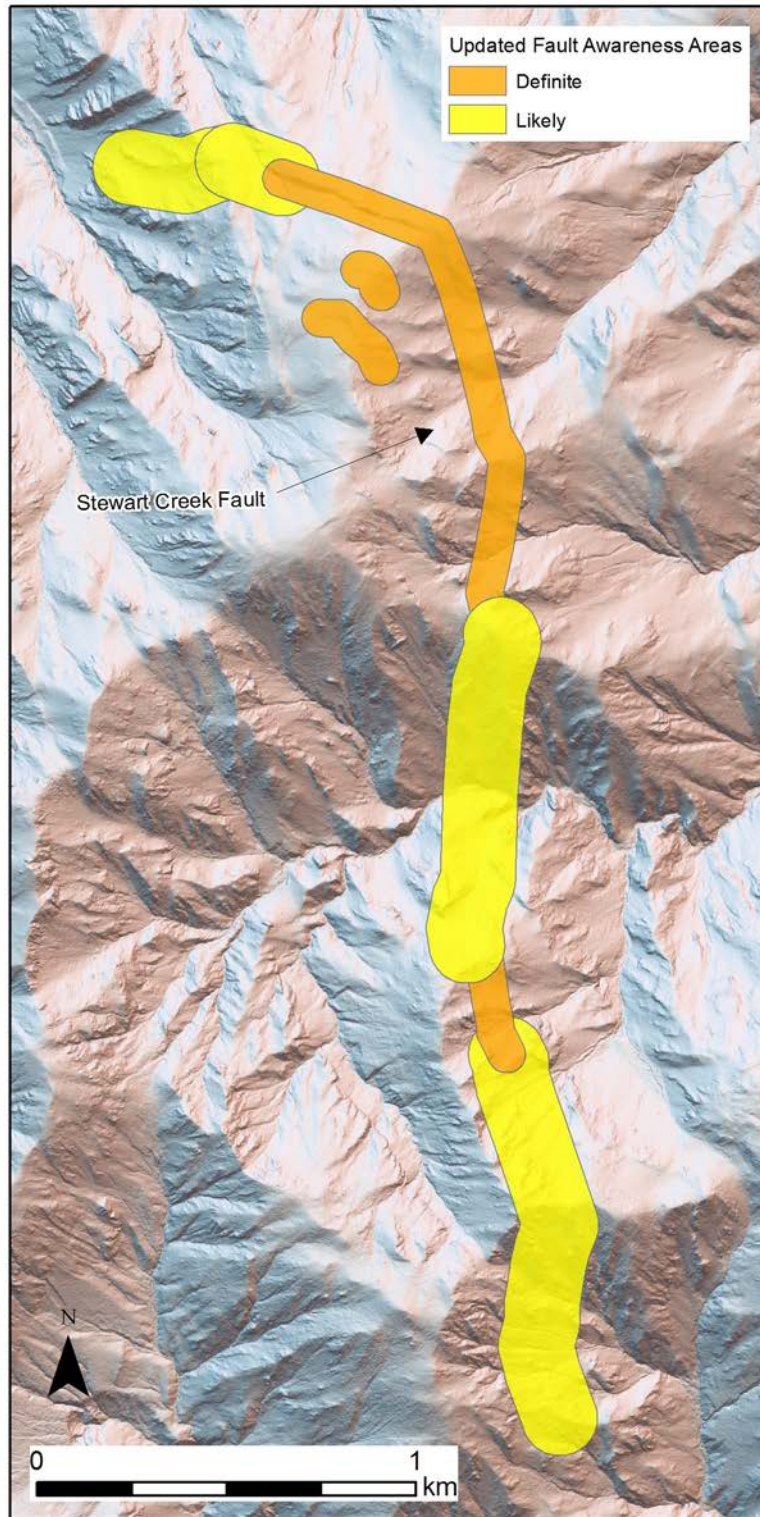
Figure A1.7 Updated Fault Awareness Areas for the Stewart Creek Fault.

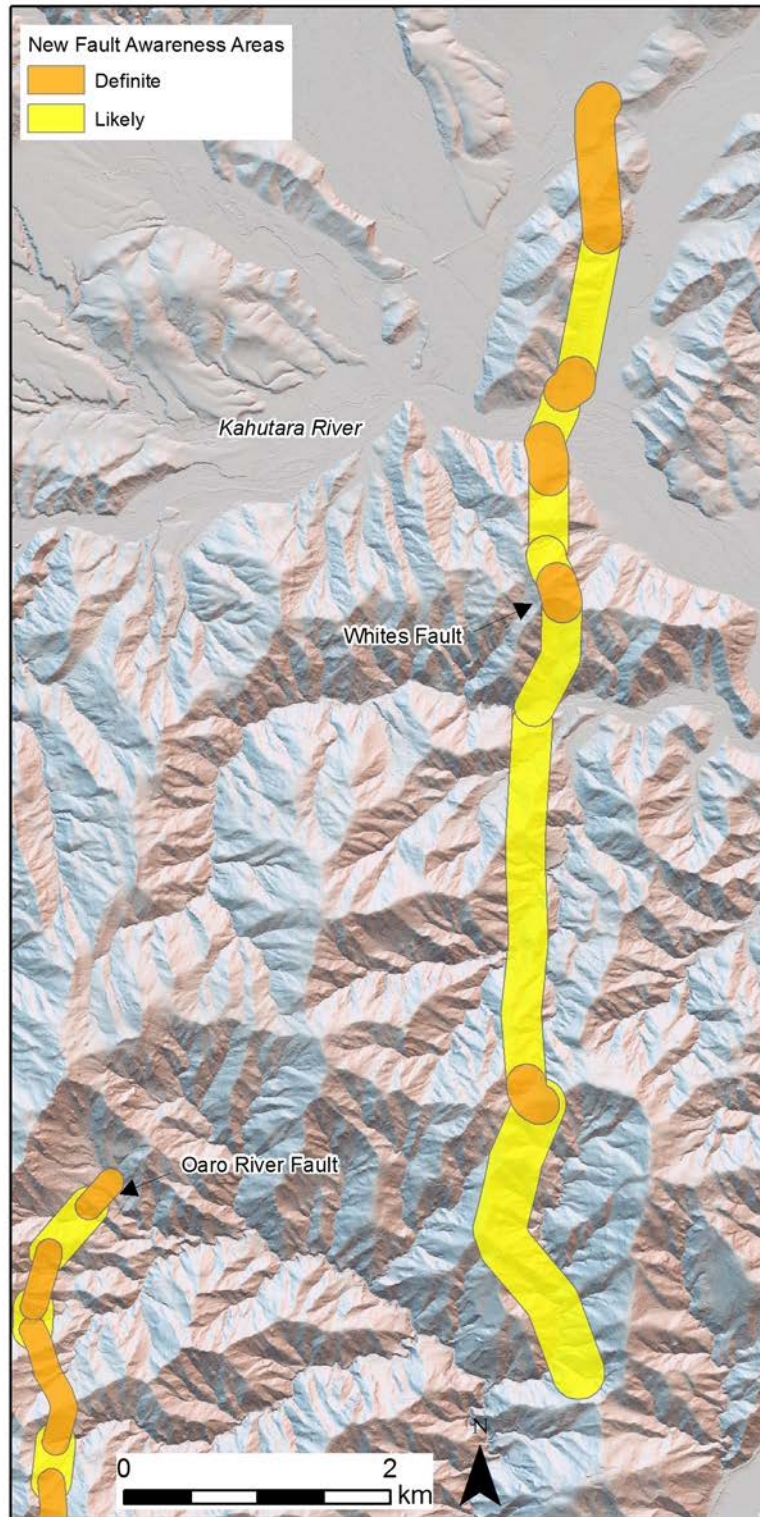
Figure A1.8 New Fault Awareness Areas for the Whites Fault.

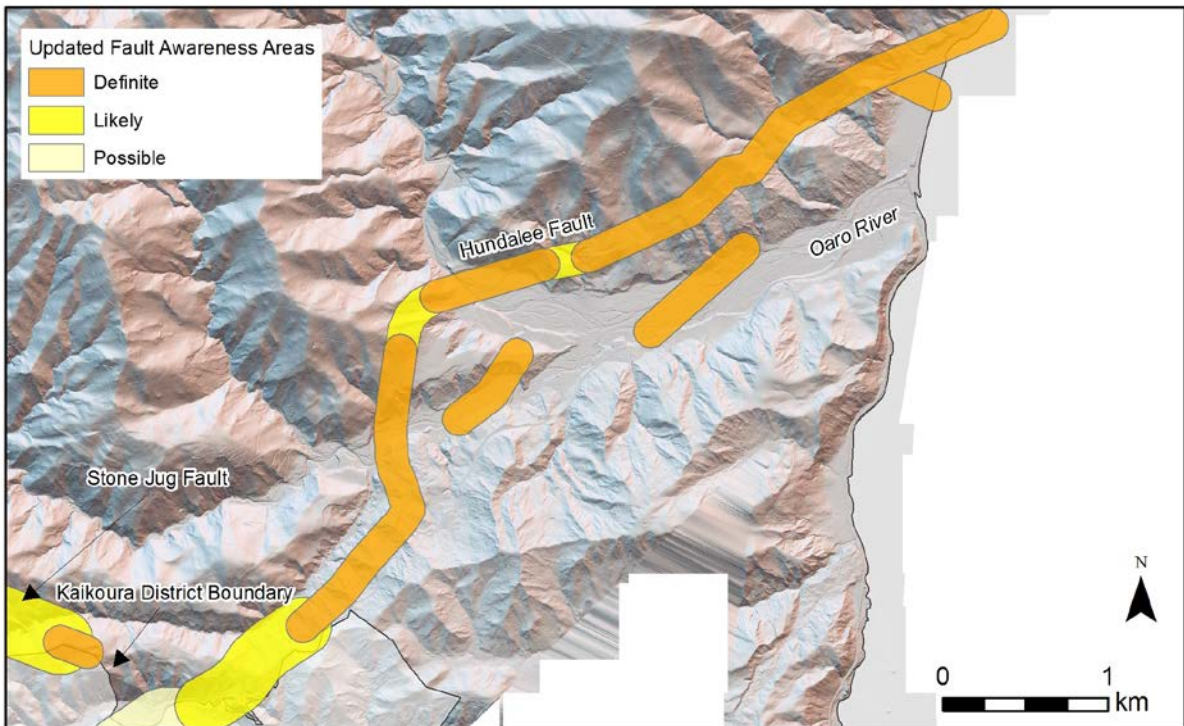
Figure A1.11 Updated Fault Awareness Areas for the Hundalee Fault.

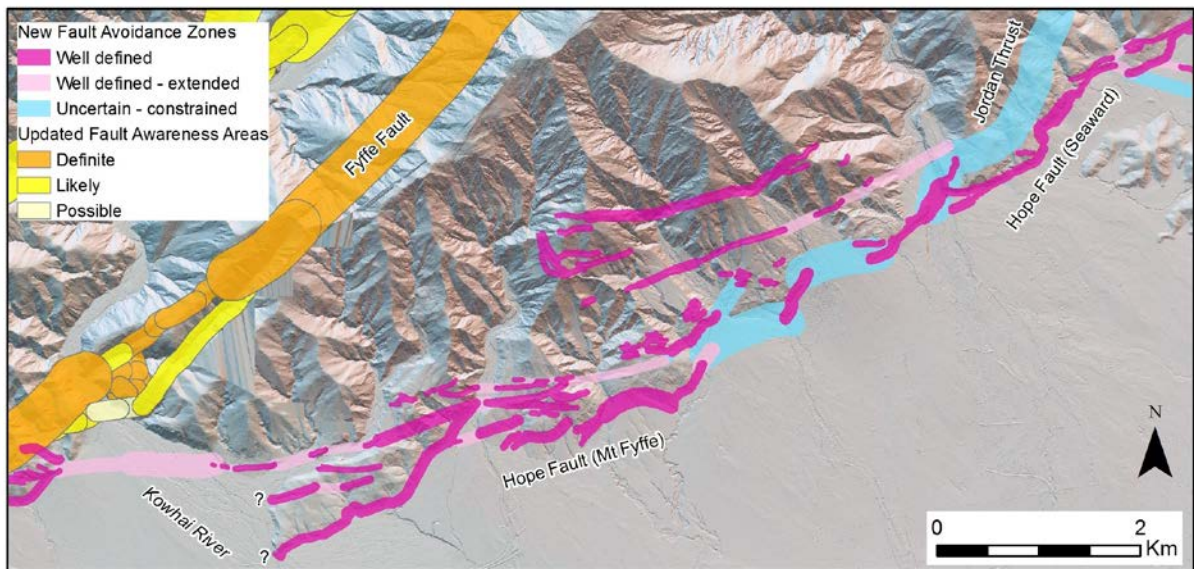
Figure A2.5 New Fault Avoidance Zones and updated Fault Awareness Areas for the Mt Fyffe Section of the Hope Fault.

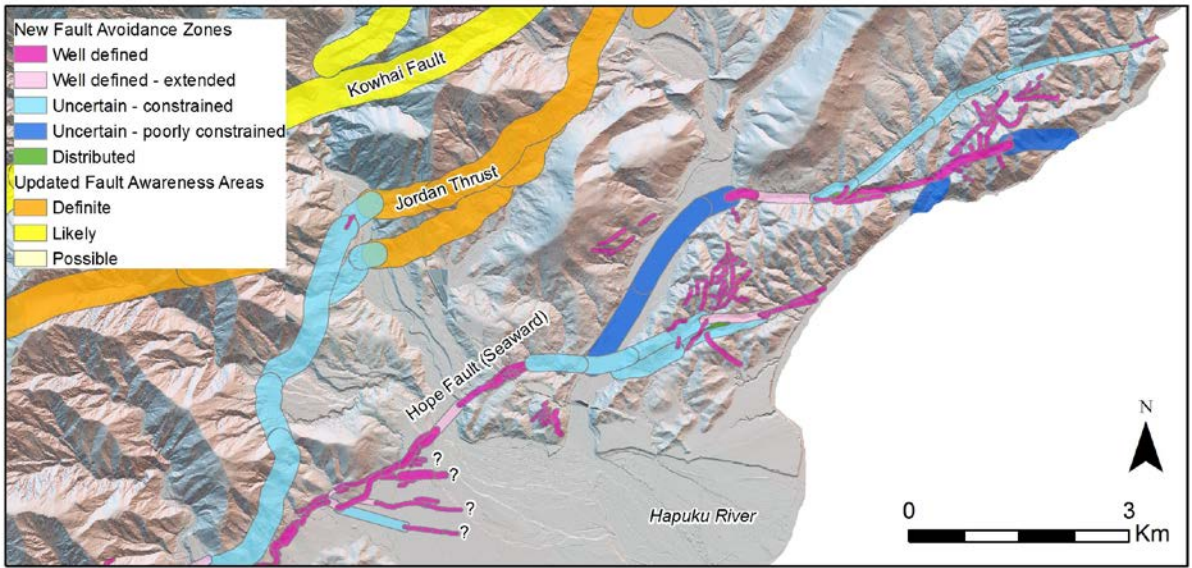
Figure A2.6 New Fault Avoidance Zones and updated Fault Awareness Areas for the Seaward Section of the Hope Fault.
